# COVER Hatch sealing assessment

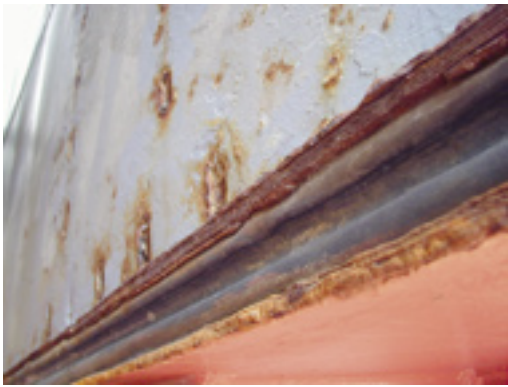
Rubber seal with permanent impression.

See sketches "A" & "B" and photo of panels resting firmly on the coaming without being battened down and rubber with excessive impression, which would indicate a potentially questionable sealing property.

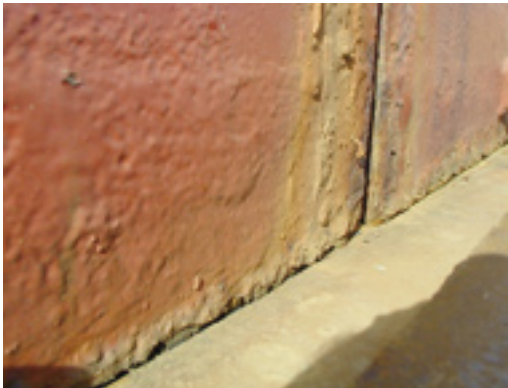
Panels resting freely onto coaming.

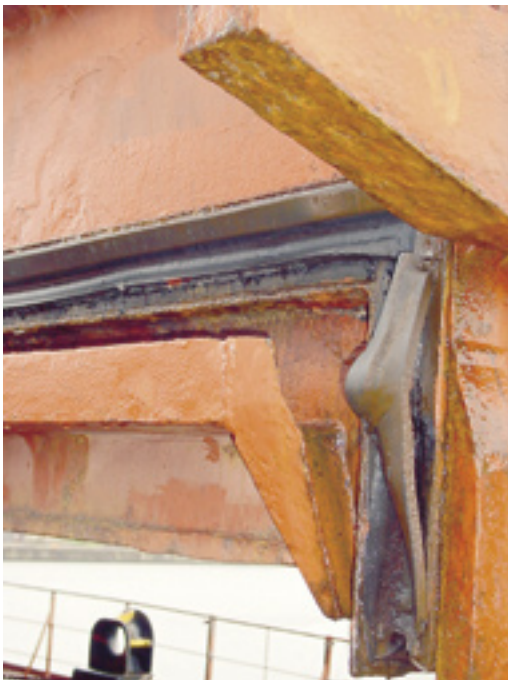
Attempt to upgrade seal with flat rubber.

Having said this, a comment on how to improve the sealing properties for a shorter period of time, for example for attaining a better position for a permanent upgrading, is to insert flat rubber, 5-6 mm thick, in the channel behind the old rubber, hence achieving a temporary satisfactory sealing. We would advise strongly against the practice of gluing flat rubber to the surface of the old rubber, with its permanent impression, since there can be no way of checking what is happening to this application at that moment the compression bar and rubber touch and there is a slight sliding movement before the panel has settled. See photo to the left.
