Hatch Cover Supplement

An expensive problem with a low-cost solution

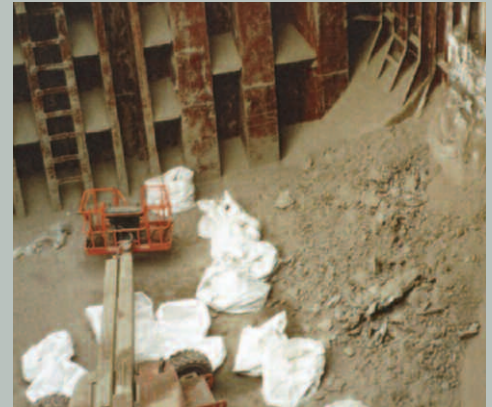
Water damaged cargo

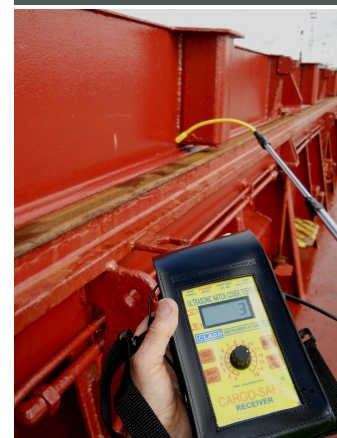
Ultrasonic testing

Ultrasonic leakage detection equipment was introduced some years ago to overcome difficulties with the hose test. An ultrasound transmitter is placed in the empty hold or on top of the cargo stow, with the hatch covers closed. An ultrasound detector is then moved by the surveyor around the outer sides of the cover and the cross-joints to locate any leaks.

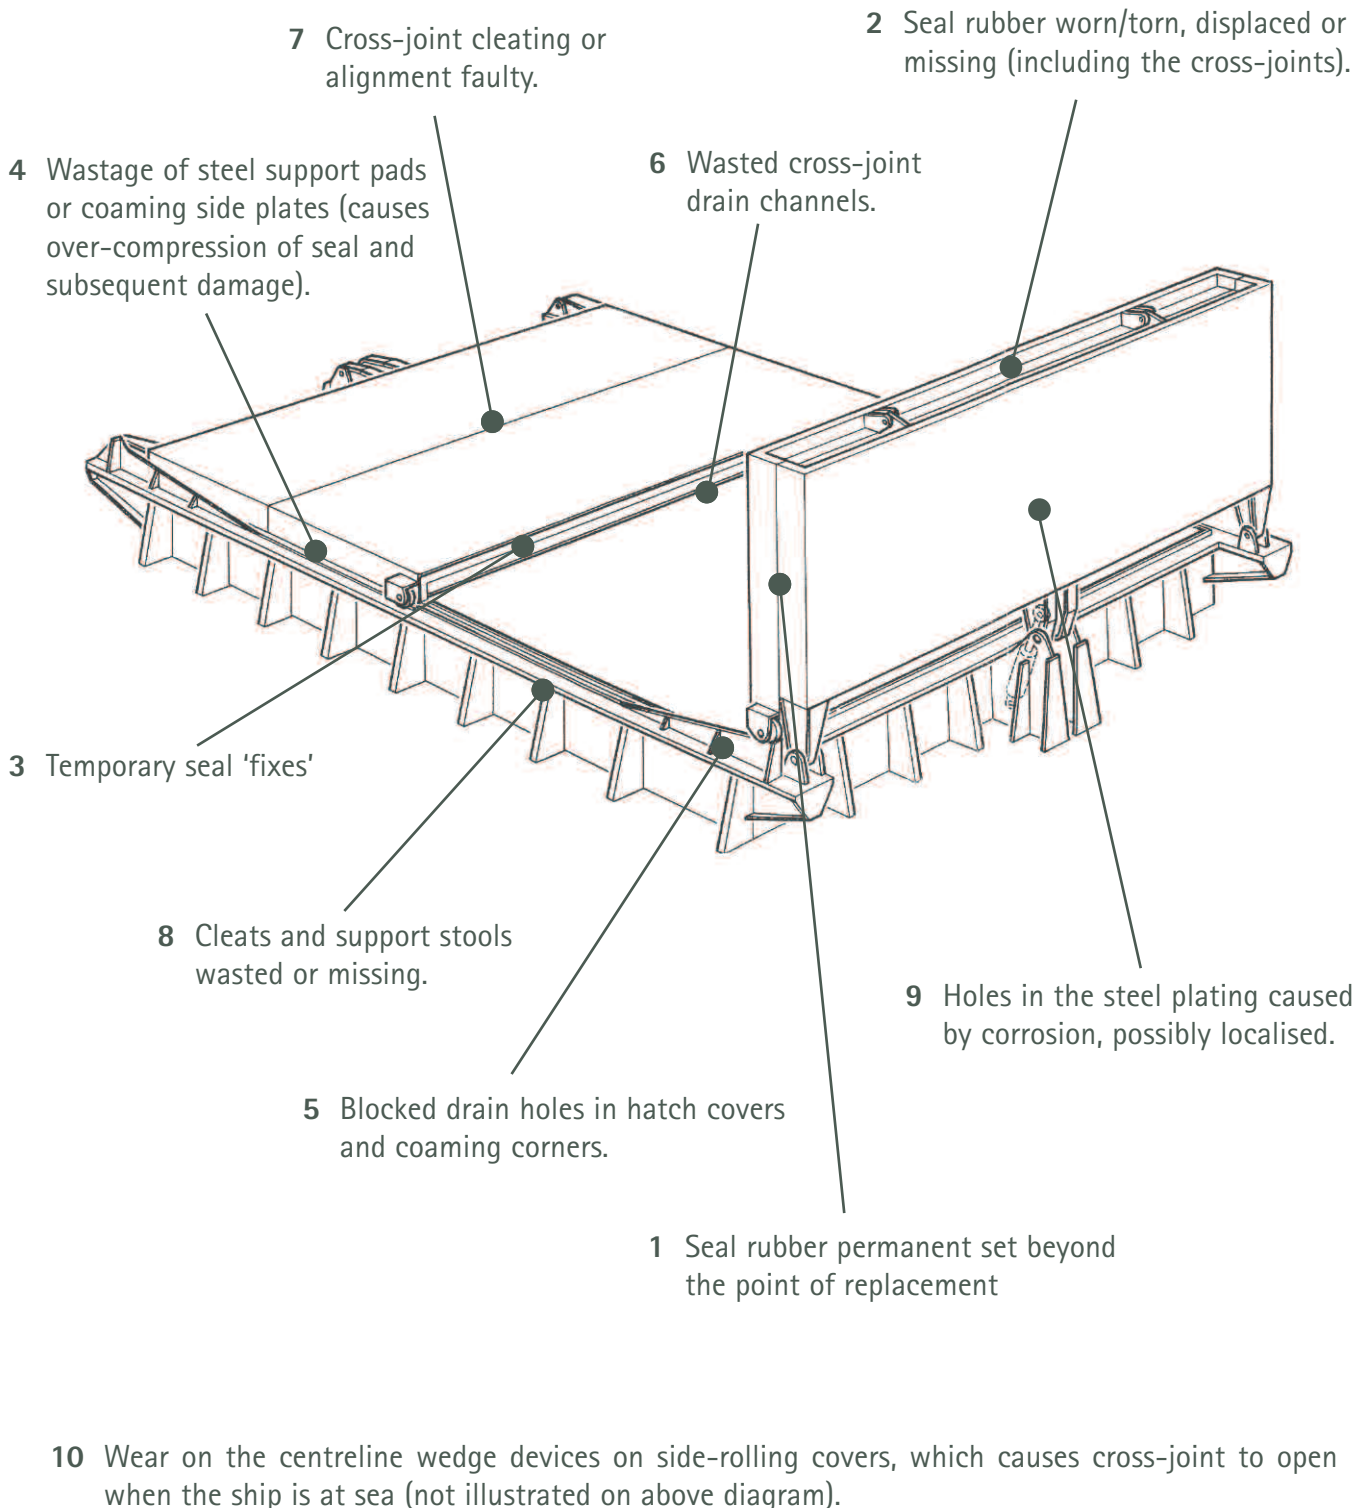
Top 10 hatch cover defects

The top 10 hatch cover defects giving rise to claims for water damage are based on experience of many hatch cover surveys and damage claims. In most cases, the cost of early remedial work which would avoid possibly significant claims is not large.

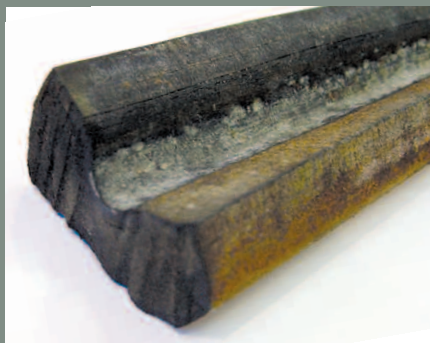
Permanent Set

More commonly, the over-compression causes the elasticity of the seal to be lost resulting in a deep groove in the rubber known as 'permanent set'. It is quite easy to measure the depth of the permanent set using a ruler or a gauge. This should then be compared to the designed compression of the seal (to be found in the hatch cover operating and maintenance manual that will be onboard). The simple rule for replacement of the seal is:

When permanent set reaches half the design compression – replace the seal.
